# **WORK SAMPLES**

# Waterloo, NY - Downtown Revitalization Consulting

## Municipal Design Services and Community Organizing

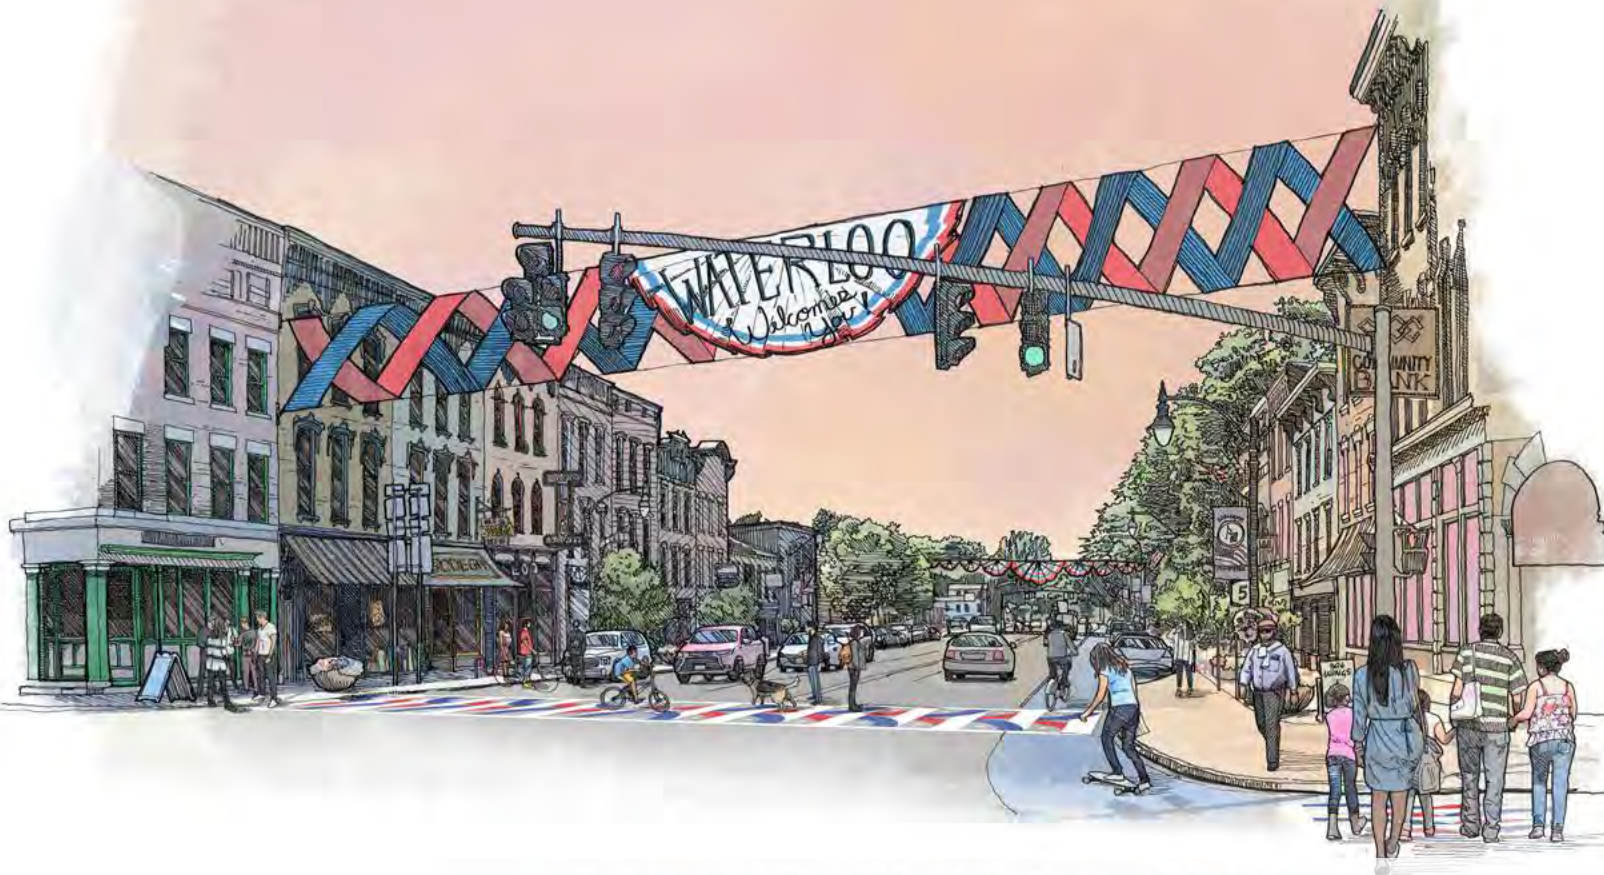
## PUBLIC SPACE ENHANCEMENT MASTER PLAN

- A Crosswalks across Main Street (x4)**  
To improve pedestrian circulation through downtown, a total of four crosswalks with yellow signage is suggested along Main Street.

- B Main Street Gateway + Ramp**  
Currently, Oak Island is accessible from the large municipal parking lot behind Main Street. To link Oak Island to downtown, a gateway and ramp from Main Street is suggested to bring foot traffic to the trail in a safe and convenient way.

- C Vern's Way Trail-head improvements**  
To better utilize Vern's Way as a recreational trail linking downtown to Oak Island, a trail head is suggested to provide amenities and possible event space, as well as fitness equipment stations for an ongoing population.

- D Lower Vern's Way Improvements**  
The northern portion of the trail is a paved for easy access, however the South portion along the canal is only accessible via an old staircase and has a rough, uneven surface.

- E Oak Island public improvements**  
Oak Island, due to its open history and potential linkage to the downtown core, would be a prime location for larger events requiring amenities such as bathrooms, electricity, etc. Our recommendations for the park would include additional public seating, a stage.

- F Community Center Dog Park**  
The potential for a small, fenced-in dog park is suggested for an area adjacent to the community center.
- G Lafayette Park Improvements**  
Convenient location for events and vendors that require loading/unloading and parking spaces, or a small food trailer.

- H Dempsey Park Improvements**  
Dempsey Park, due to its small size and central downtown location would make it a great venue for small events and pop-up events. To facilitate these events, some small improvements such as outlets, storage for chairs, and access to nearby resources are suggested.

- I Bowling Alley plaza**  
The bowling alley is a well-used building on the verge of collapse, however it also has the opportunity to provide a public space. Our proposal is to create an all-season space that can house events year-round, and act as a park for downtown residents.

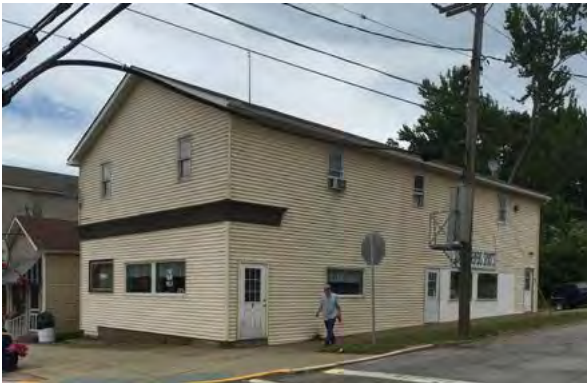
Shared office concept

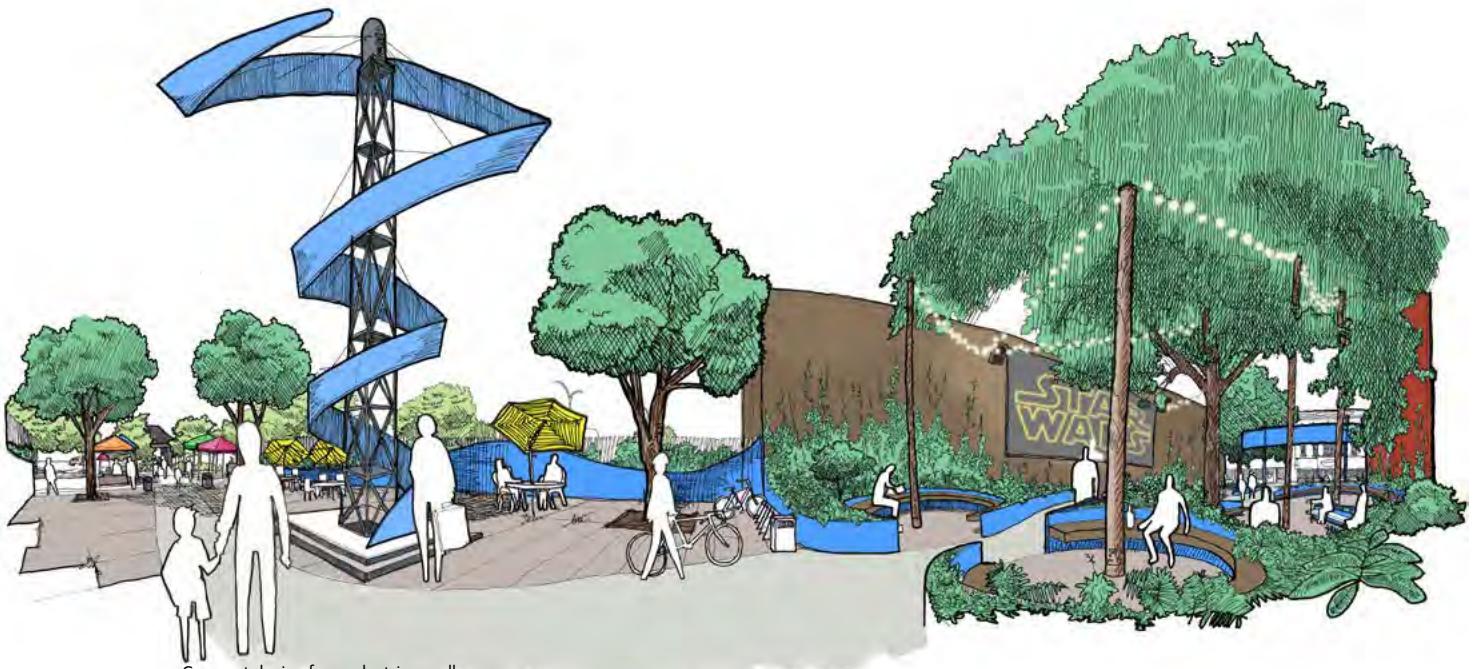
Concept design for pedestrian walkway  
leading to farmers market

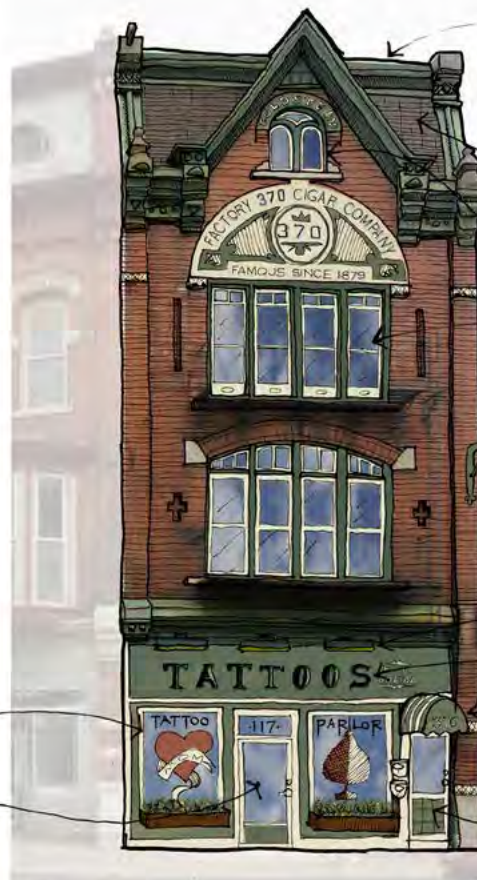
REPAIR AND PAINT  
EXIST. CORNICE AND  
CAP

REPAIR EXIST. MANSAARD  
ROOF

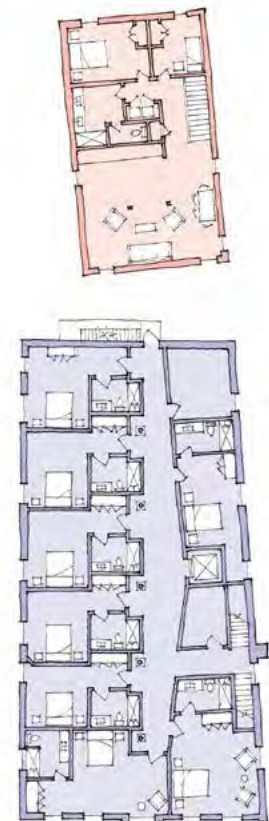
UPPER FLOOR HOTEL

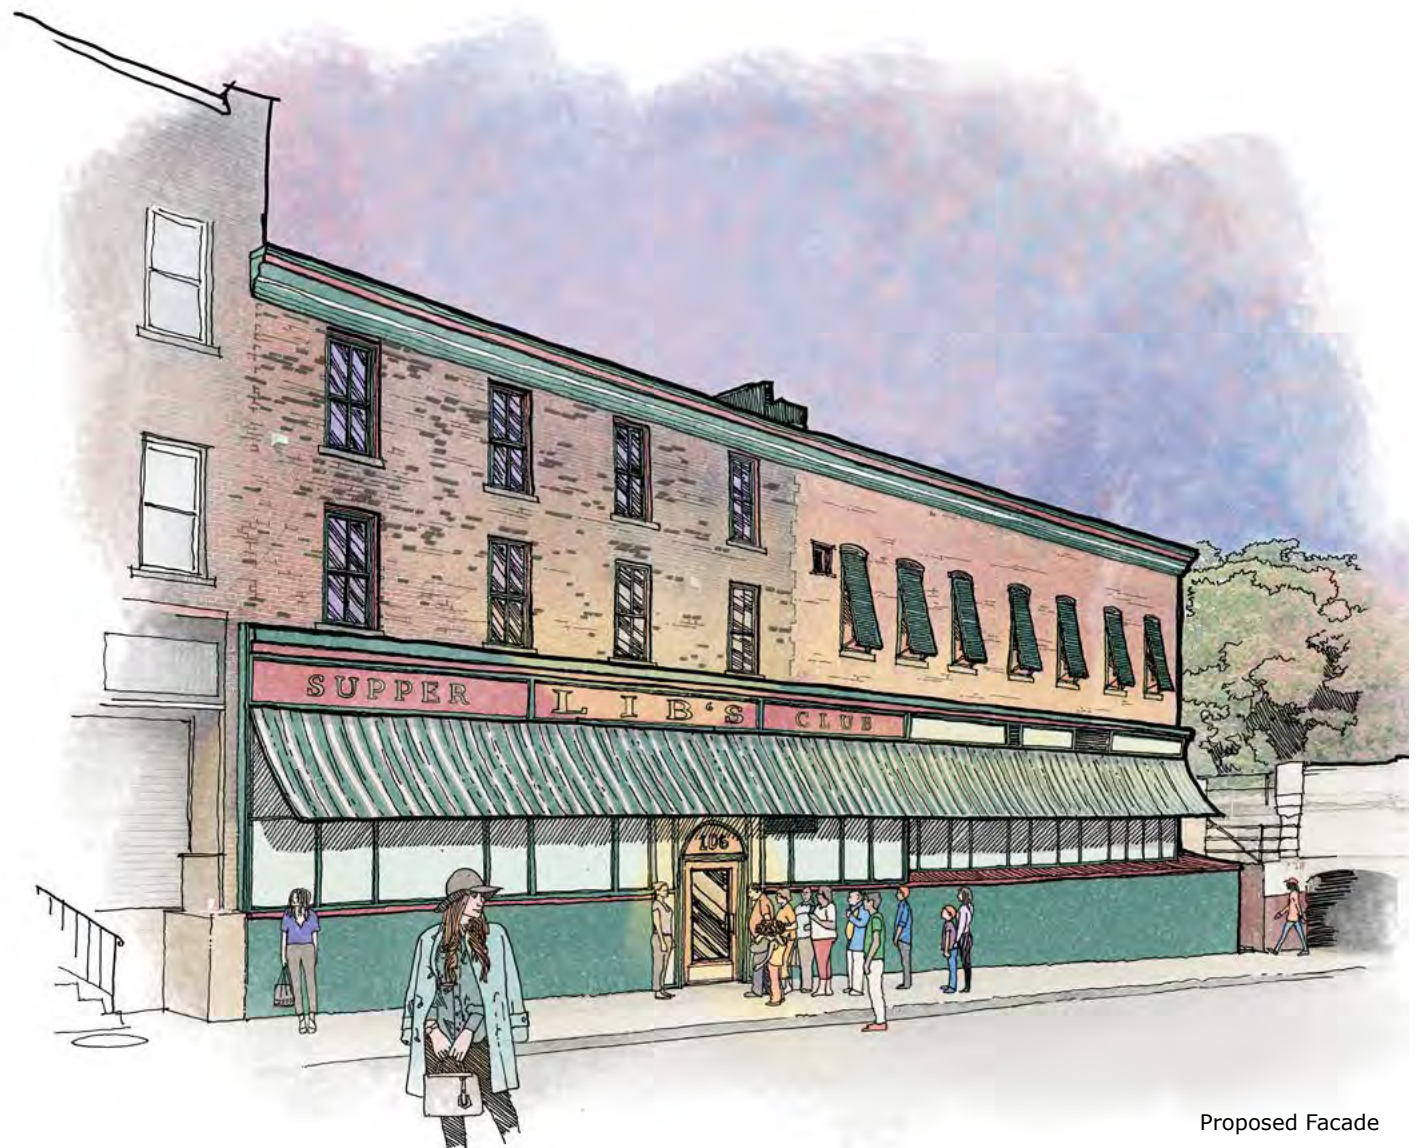
Proposed Facade

After the century old building was awarded 100k in New York Main Street funds, we worked directly with the building owner and the city to make a design that would accommodate the goals of the NYMS program as well as the budget of the owner.

We provided several design alternatives, coordinating directly with local contractors to secure accurate bids, assess feasibility, and develop a final proposal.

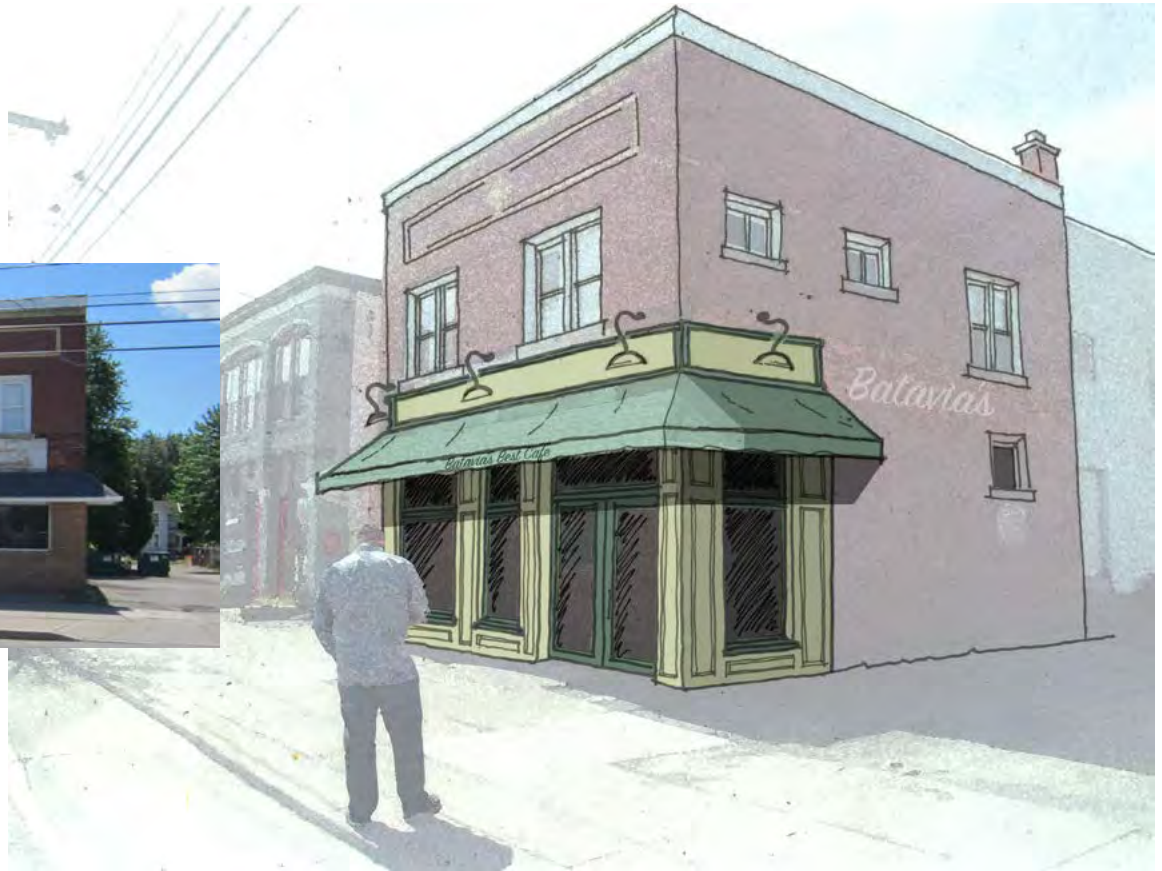
Proposed Facade

We measured and drew existing conditions, and developed several design concepts for the first floor re-use and a new facade for a small but visible commercial property on Ellicott St. Each option was weighed from a business standpoint, where the return on investment was weighed against renovation and maintenance costs over the life of the project.

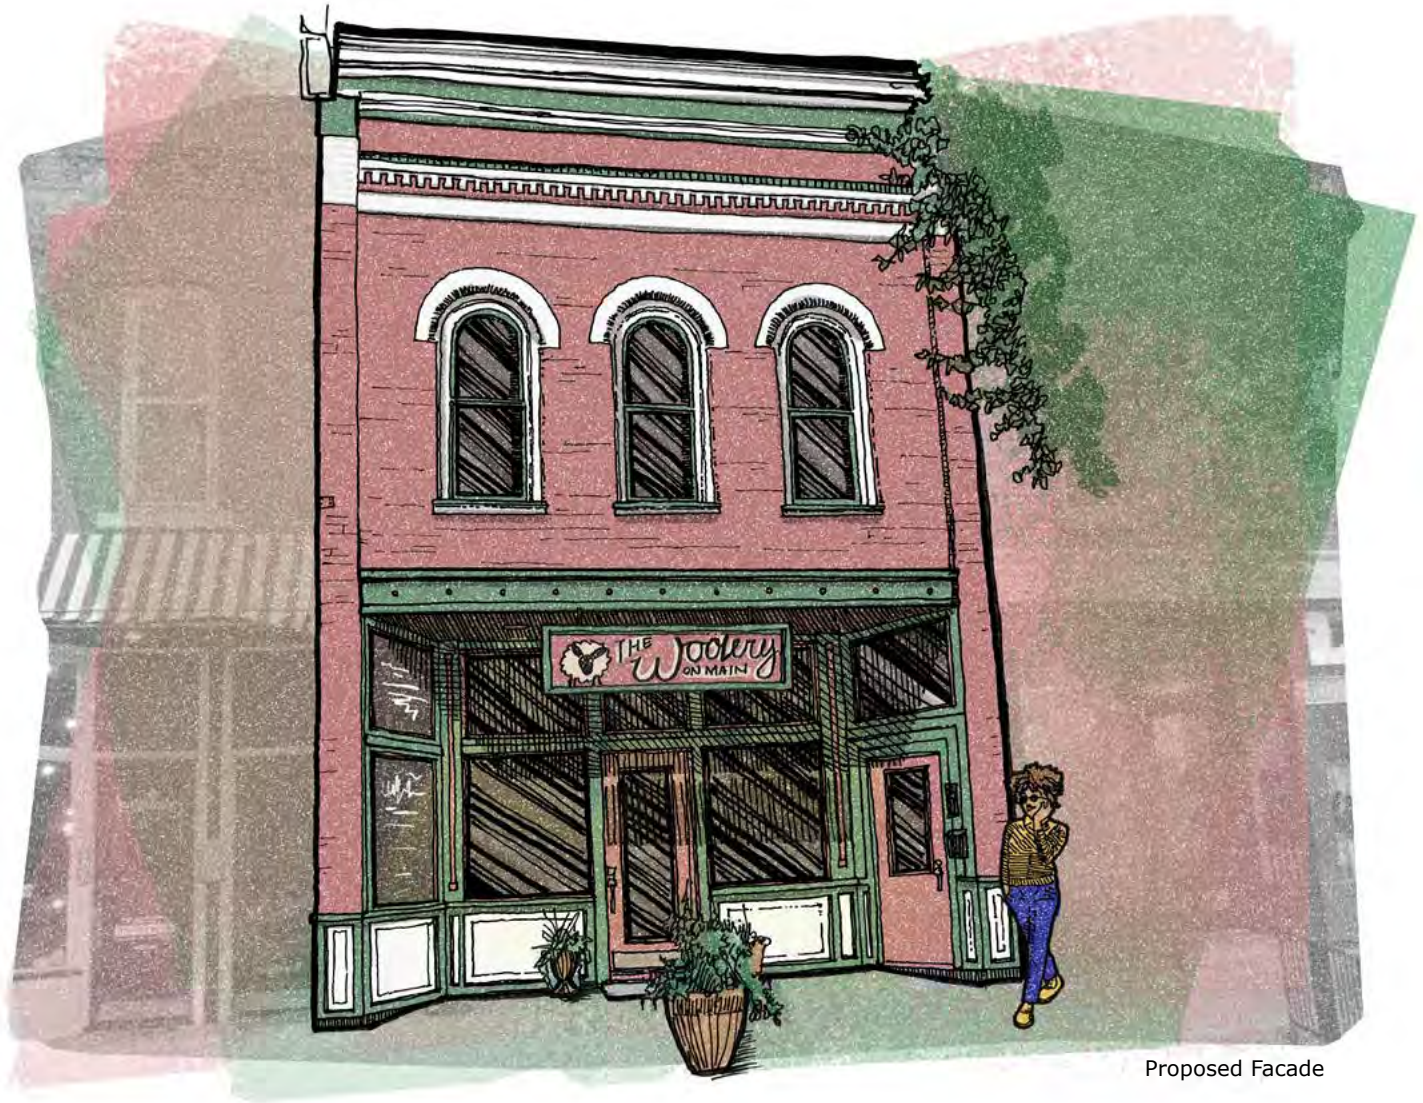
Proposed Facade

Through an exploration of historic photos and documents, we developed a facade design that would both respect the historic turn-of-the-century character of Livonia while also coming to terms with the outdated 1950s storefront renovation we had as a constraint.

After some investigative demolition, we were able to work directly with Livingston County Development to create a design that would be of high visual impact without requiring a huge cost, allowing both the business and downtown to grow symbiotically.

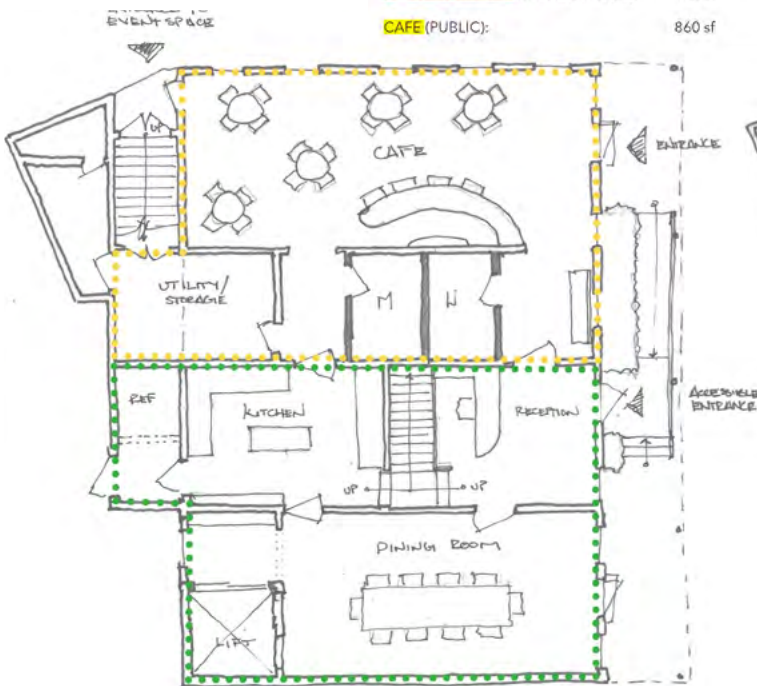
FIRST FLOOR PLAN

BED & BREAKFAST (PRIVATE SPACES):	1,680 sf
BED & BREAKFAST (SHARED SPACES):	925 sf
CAFE (PUBLIC):	860 sf

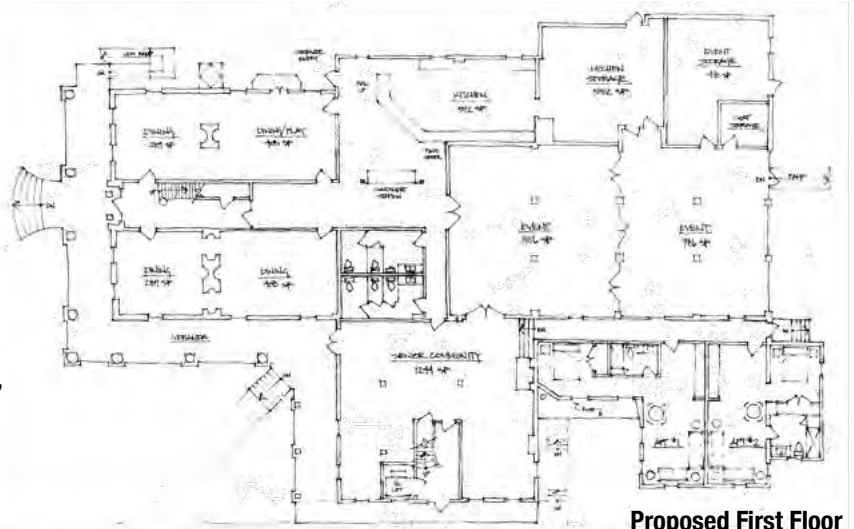
**Proposed First Floor**

The feasibility study looked into the possibility of modernizing the ground floor commercial operations into that of a restaurant, providing "aging in place" units upstairs to seniors, and updating the apartments in the adjacent addition. We incorporated cost analysis, site planning, exterior upgrades, and space planning for the interior occupants to have privacy when needed.

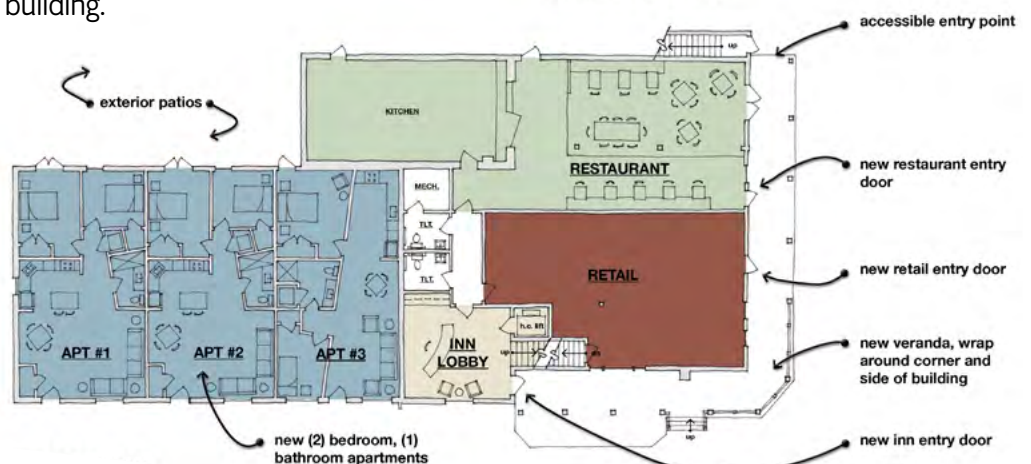
## PROPOSED FIRST FLOOR

Our feasibility study was for the adaptive reuse of the building into commercial space on Main street, with an upper floor Inn serving short term visitors and several first floor apartments in the former bunkhouse. Our study included preliminary cost estimates, parking and site use studies, adaptive reuse complying with current accessibility requirements, and facade recommendations to emphasize the characteristics of the building.

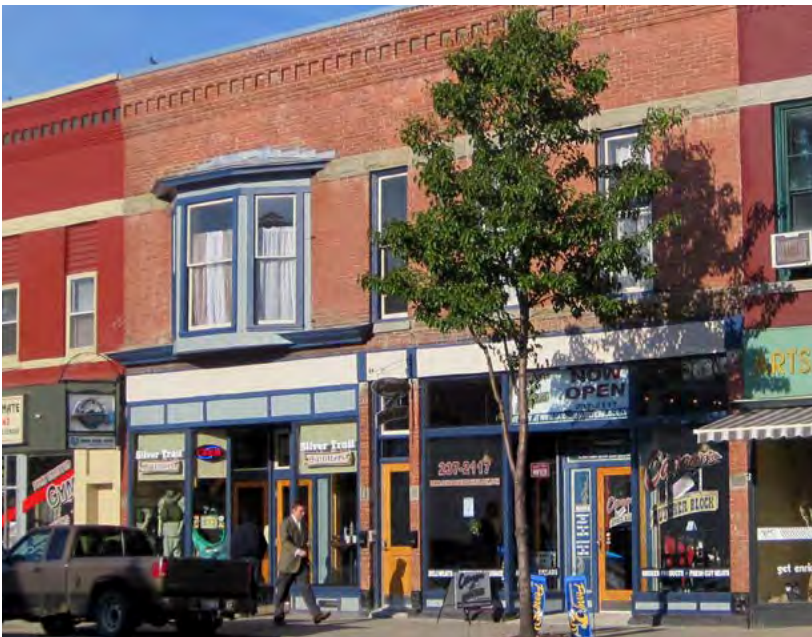
*Howell Building - After*

Part of a broader approach to small town revitalization, this property continues the ripple-effect of prior investments and helps to return our Main street to a vibrant mixed-use, live-work community. Apartment details consist of playful yet elegant juxtaposition of old and new, and the project as a whole meets Secretary for the Interiors Standards for Historic Preservation projects.

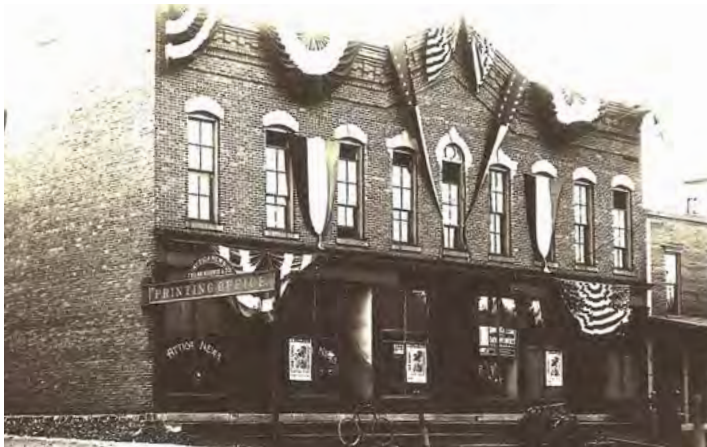
Before

In. Site: Architecture developed a rehabilitation proposal for this anchor building on Market Street. The first floor storefront had been entirely enclosed, and upper windows had been boarded up or reduced in size, leaving this prominent facade blank and unwelcoming.

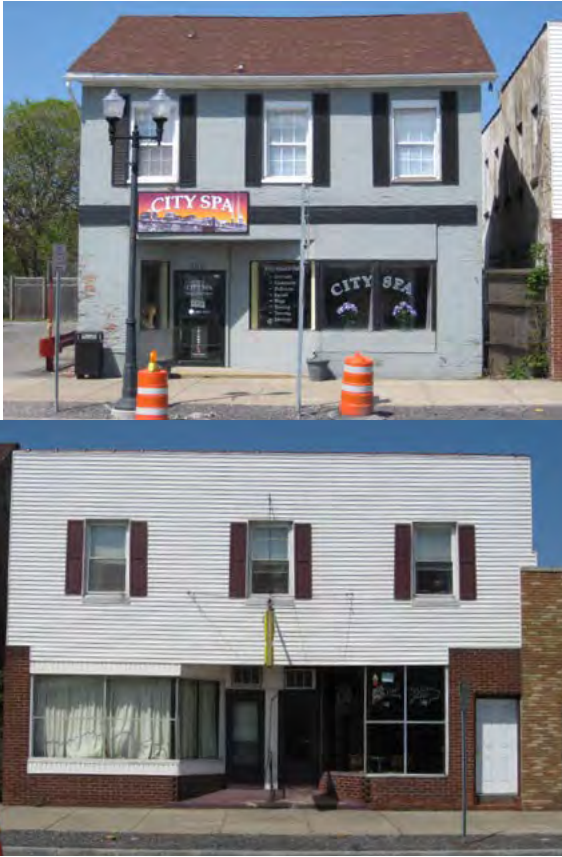
Before

The historic City Spa building had deteriorating brick and was in need of a face-lift. In this rehabilitation, the

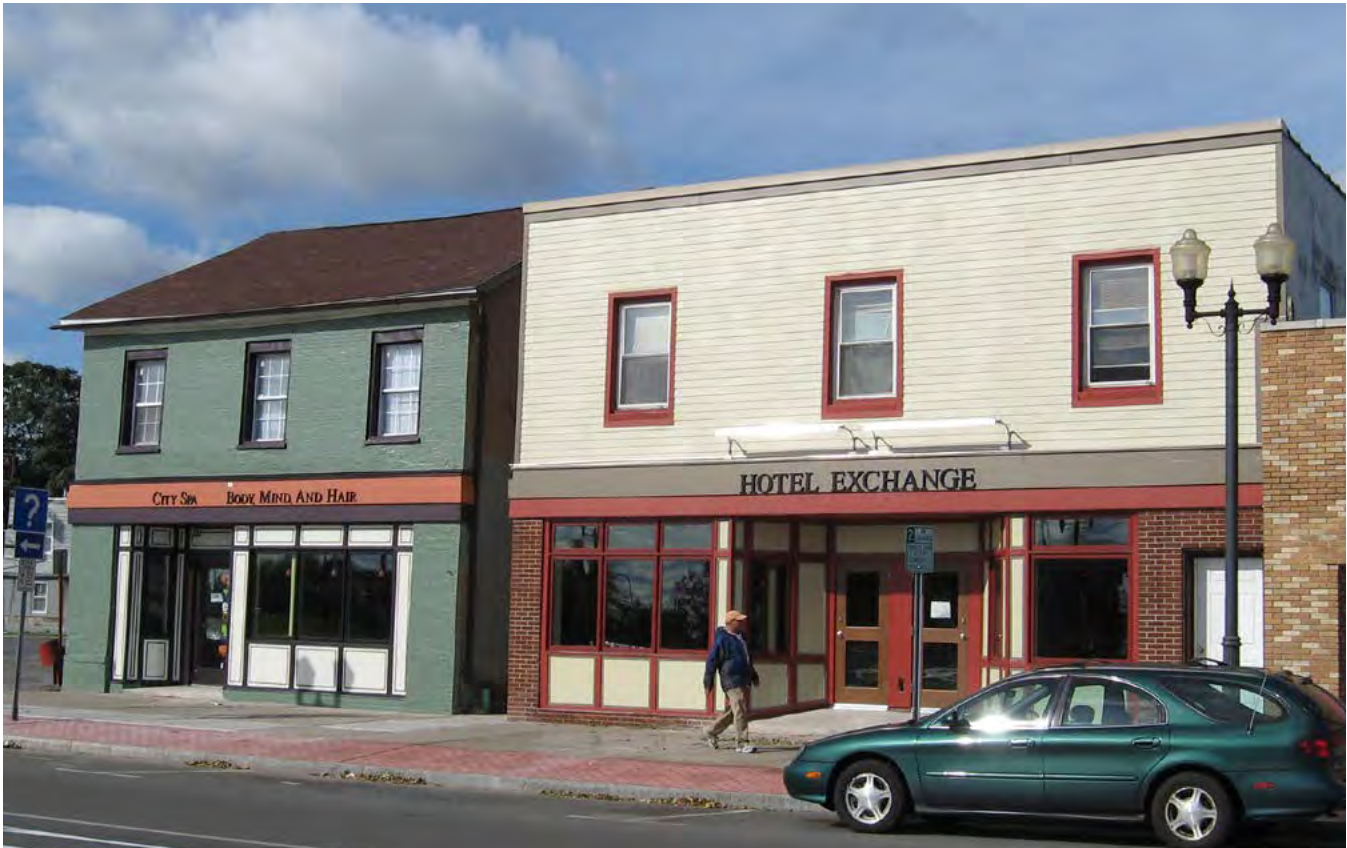
After

brick has been restored and the inviting storefront entry is more energy efficient. The sign-board is improved and details are sympathetic with the original building. The adjacent building gets a similar treatment - new siding at the second level and improved entry lighting help draw in clientele. The two buildings read as a block, yet color palettes and other subtle touches differentiate the businesses.

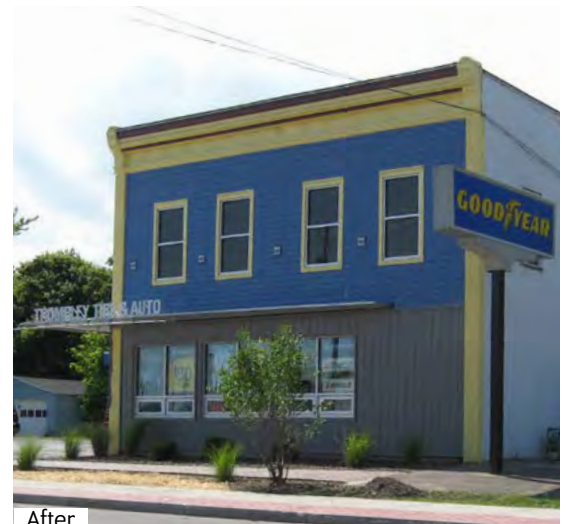
After

For Advantage Auto, we introduced a new commercial window wall that angles in towards the entry doors. This solves three problems – entry protection from the weather, room to ramp up to floor level and eliminate a step, and enhanced façade depth and interest. Meanwhile, three signature aluminum “shadow rails,” provide the most overt reference to an automotive pedigree.
